Sediment budget as evidence of land-use changes in mountainous areas: two stages of evolution

Luc Descroix, Emmanuele Gautier, Anne Laure Besnier, Okechukwu Amogu, David Viramontes, José Luis, Jose Luis Gonzalez Barrios

Luc Descroix, Emmanuele Gautier, Anne Laure Besnier, Okechukwu Amogu, David Viramontes, et al.. Sediment budget as evidence of land-use changes in mountainous areas: two stages of evolution. Sediment Budgets, 2006, 2. ird-02153553

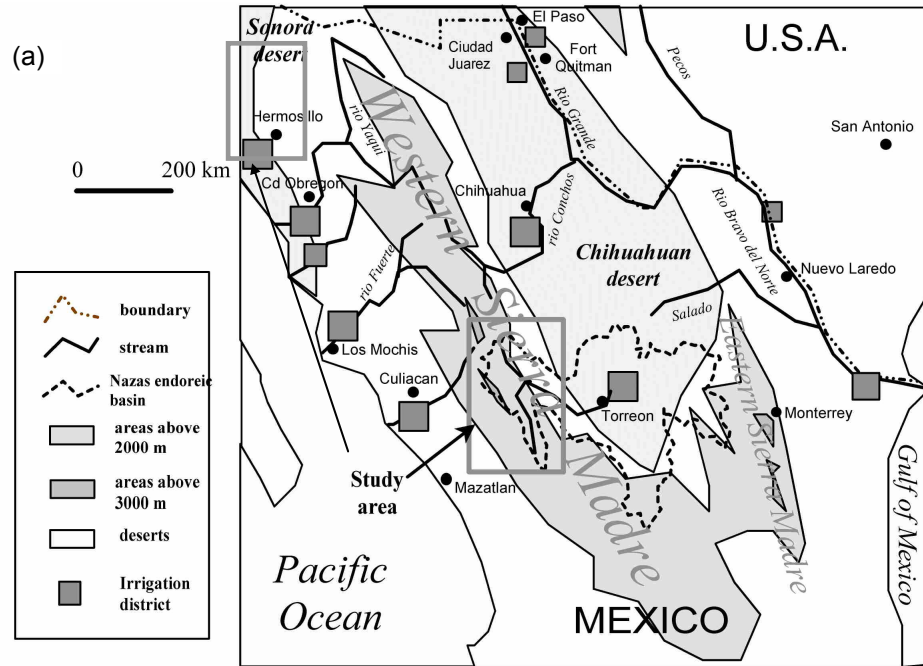
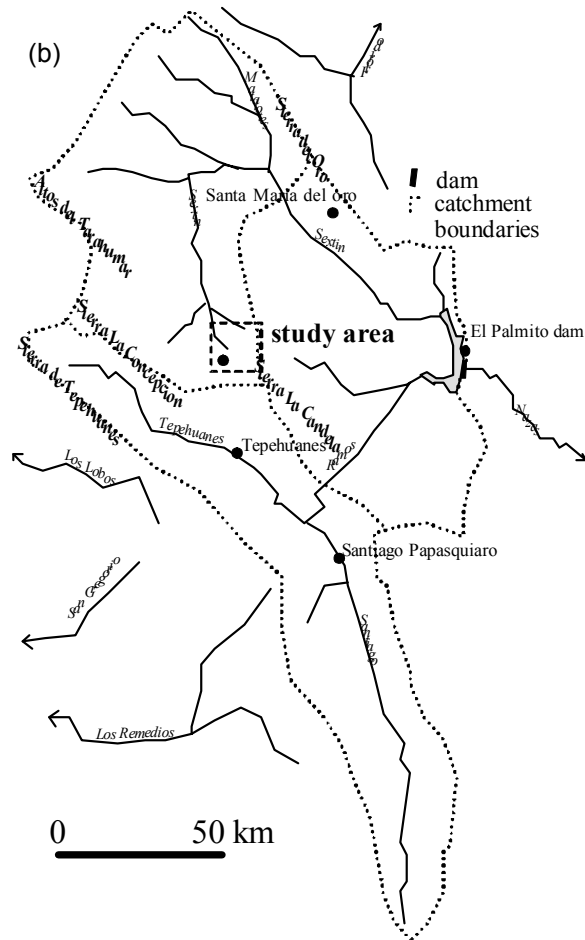
Fig. 1 (a) Location of study areas in northern Mexico: Sonora and Matapé basins in the Northwest, and the Nazas Basin in the centre. (b) The Upper Nazas basin: the study area, and the location of the experimental plots.

In Western Sierra Madre (Fig. 1(a) and 1(b)), changes in surface features have been detected (Descroix *et al.*, 2001), and some of their hydrological consequences modelled, at the local scale (Descroix *et al.*, 2002). Viramontes *et al* (2003) showed the downstream consequences of these changes, by analysing the evolution of river regimes. They highlighted, among others: (a) an increased lag time in hydrological response to rainfall in basins; (b) the decrease of baseflow (and the increase of flood flows); (c) the reduction of soil water capacity, due to a decline in infiltration as a result of a decrease in the fine particle content of the soil at both local and basin scales; (d) the reduction in soil moisture depletion time; and (e) changes in baseflow indices.

- (a) a synthesis of studies and measurements performed during the 1990s:
- in the French Southern Alps (Gautier, 1992; Descroix & Mathys, 2003; Descroix & Gautier, 2002), in seven experimental catchments located in the Diois, Baronnies, and Préalpes de Digne massifs (Fig. 2(a));
 - in the Western Sierra Madre (Descroix *et al.*, 2001, 2002, 2004), in five experimental catchments of the upper Rio Nazas basin (Durango State) (Fig. 1(b)).
- (b) a series of observations based on photographs and documents :
- a hydrographical study of the Buëch River in the French Alps (Fig. 2(b));
 - an aerial survey of the Matapé and Sonora River Basins (Sonora State, México) (Fig. 1(b));

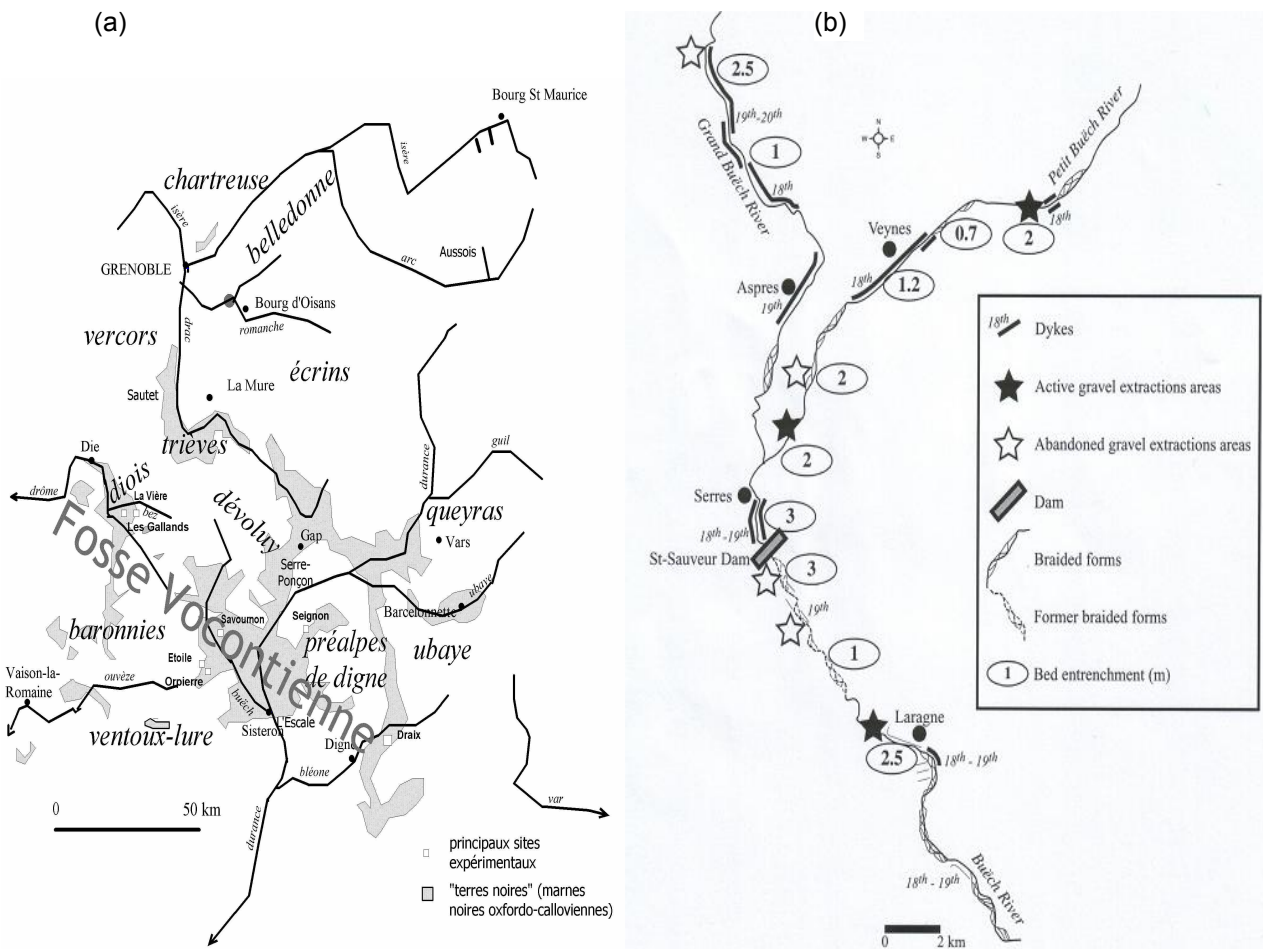
Fig. 2 (a) Location of Buëch valley in the southern French Alps. (b) Degree of riverbed entrenchment in the Buëch River over the three last decades.

In alpine areas, bedload transport has declined considerably since the end of the 19th century. In the past (pre 1900s), in the southern French Alps, two underlying rock types have provided heavy volumes of sediment: black marls (Fig. 2(a)) and rock flour from glacial moraines. It has been estimated that erosion in black marl areas ranged between 7 and 11 mm year⁻¹, whereas erosion rates in glacial flour areas ranged between 14 and 18 mm year⁻¹. Similar rates also have been observed in unvegetated sections which can represent between 5 and 20% of catchment areas. Currently, the percentage of catchment areas containing bare soil, and their associated erosion rates, has remained approximately the same. However, active reforestation has substantially limited the quantity of sediment reaching river channels because the increased vegetation has isolated the areas that are still subject to erosion and hence, precluded the material from reaching the riverbeds. The impact of the new forest growth also has been enhanced by the spontaneous growth of other types of vegetative cover. Reforestation programs were initiated by the national government (during the second Empire and then during the third Republic) in conjunction with rural engineering projects; however, much of the reforestation was spontaneous, as a result of voluntary population relocation from rural to urban areas accompanied by declining levels of silviculture and grazing.

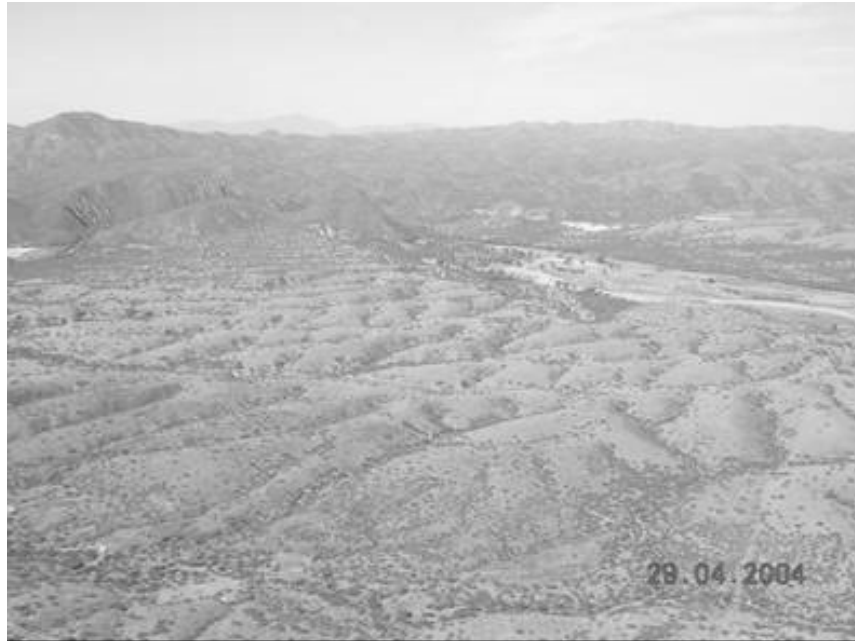
Fig. 3 Overgrazed hills in the middle basin of the Rio Sonora (Sonora State, Mexico).

For the purpose of this study, the onset of the current active erosive phase began about 50 years ago (this is somewhat arbitrary as it is based on oral communications from local inhabitants). At that time, there was little or no local agricultural activity, and grazing was limited to a few areas near former large ranches (haciendas). Based on the assumed 50-year-old onset, sheet erosion removed about 2 mm year⁻¹, over half the study area. Even so, a substantial portion of what remained was coarse material. In comparison, gully erosion amounted to 0.006 mm year⁻¹. Hence, the rate of sheet erosion was nearly two orders of magnitude greater than gully erosion. The major cause of increased sheet erosion is overgrazing (Fig. 3).

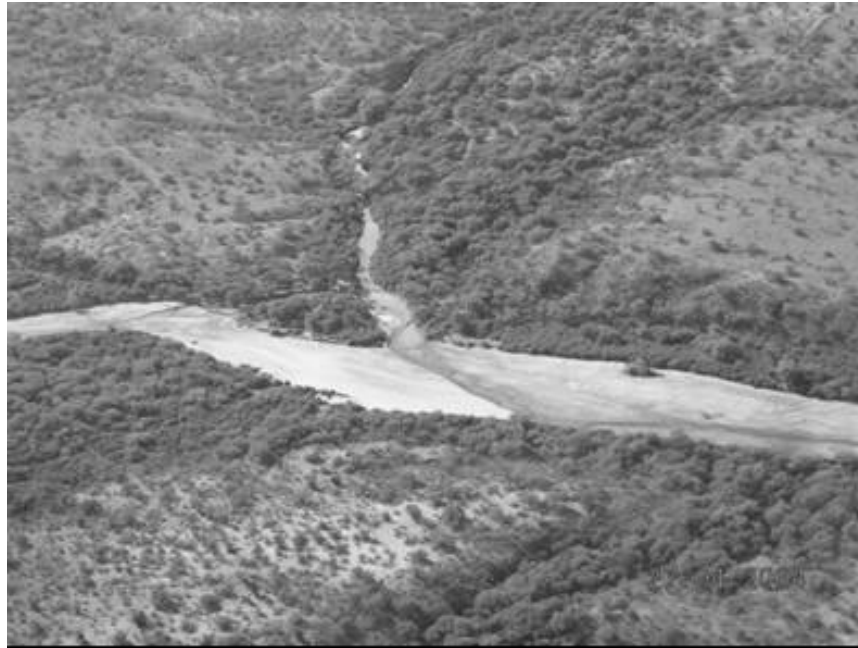
Fig. 4 Alluvial material in excess, invading the lower part of a tributary (left edge) of the Rio Matapé (Sonora State, Mexico)

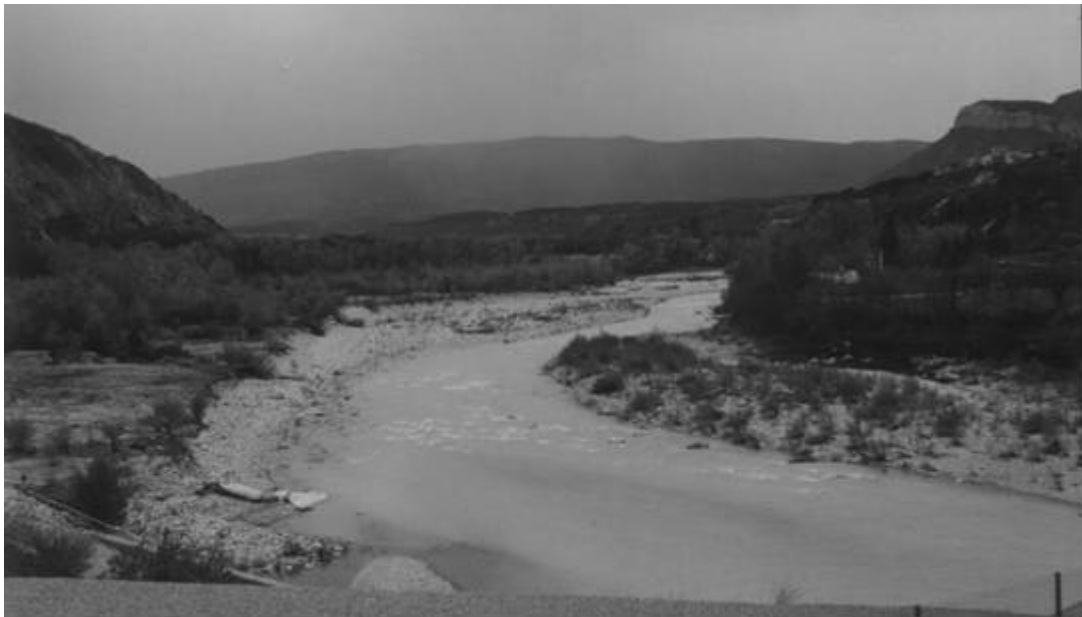
Fig. 5 The Buëch River valley immediately downstream from Saint Sauveur Dam (Hautes Alpes, France); the entrenchment of the bed (more than 3 m since 1992) in its own alluvium is detectable on both sides.
